NASA/CR-2007-214887

# In-Service Evaluation of the Turbulence Auto-PIREP System and Enhanced Turbulence Radar Technologies

*Jason B. Prince, Bill K. Buck, and Paul A. Robinson  
AeroTech Research (U.S.A.), Inc., Newport News, Virginia*

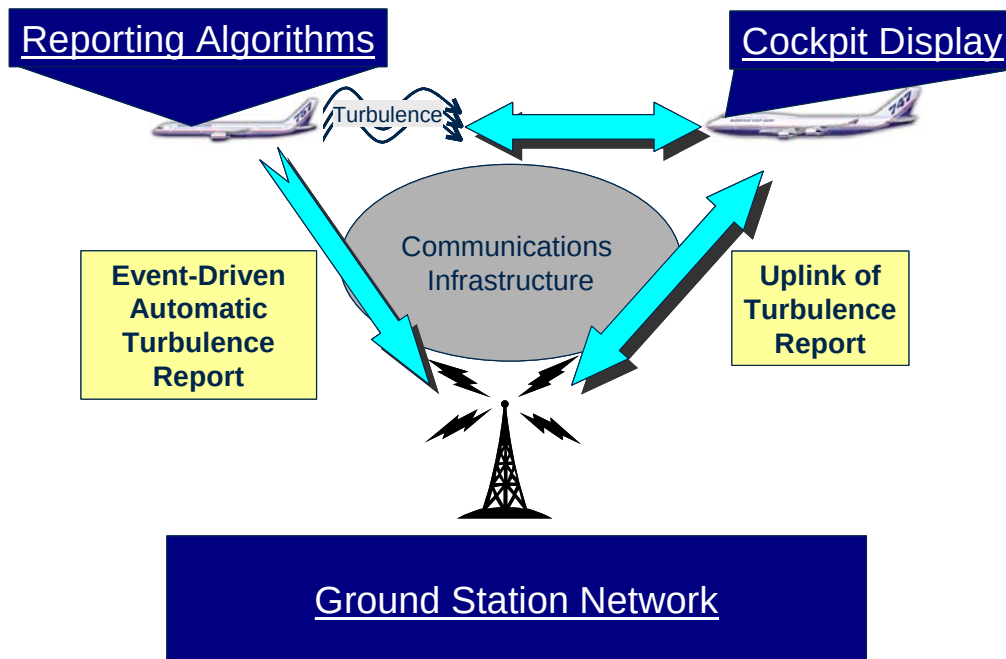
The TAPS reporting algorithms consist of three components: hazard metric ( $\sigma_{An}$ ) calculation, reporting logic, and report generation. The hazard metric is continuously calculated during flight. The reporting logic determines when a TAPS report should be generated. When the value of the hazard metric exceeds a particular threshold, a TAPS report is generated containing information on the time, location, aircraft flight conditions, and maximum accelerations experienced during the turbulence encounter. The report also contains a parameter that may be used to scale reports to other aircraft to determine the potential hazard to that aircraft. An additional benefit of TAPS is that the system would report any encounters when the aircraft exceeded the vertical load acceleration limits, defined by the aircraft maintenance manual, that require an airplane structural examination. A graphical depiction of the overall TAPS architecture is shown in Figure 3.

Figure 3: TAPS Architecture

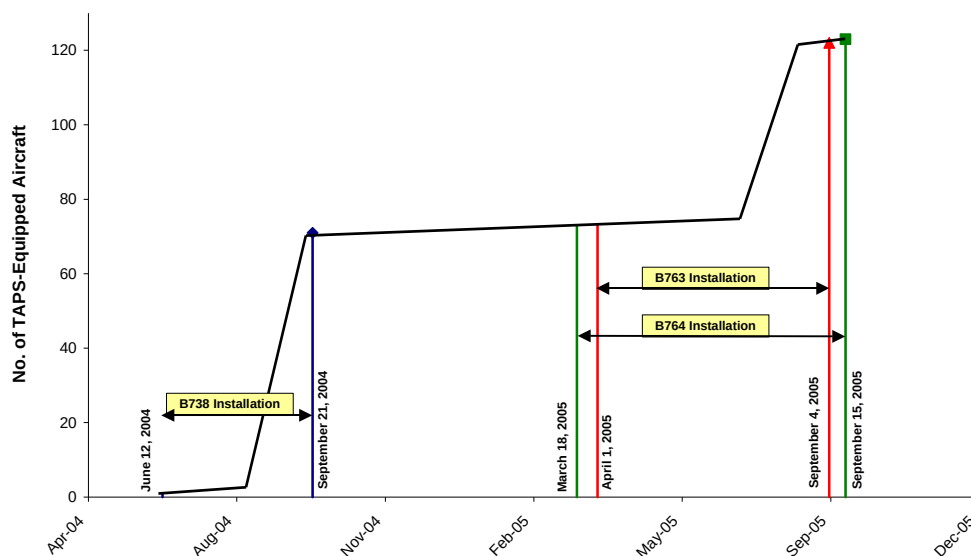
Figure 6 shows the timeline for the installation of the TAPS software on the Delta aircraft. The dates used in determining the exact installation of the algorithms on a particular aircraft coincide with the date of the first TAPS report received by that aircraft.

**Figure 6: TAPS Installation Timeline**

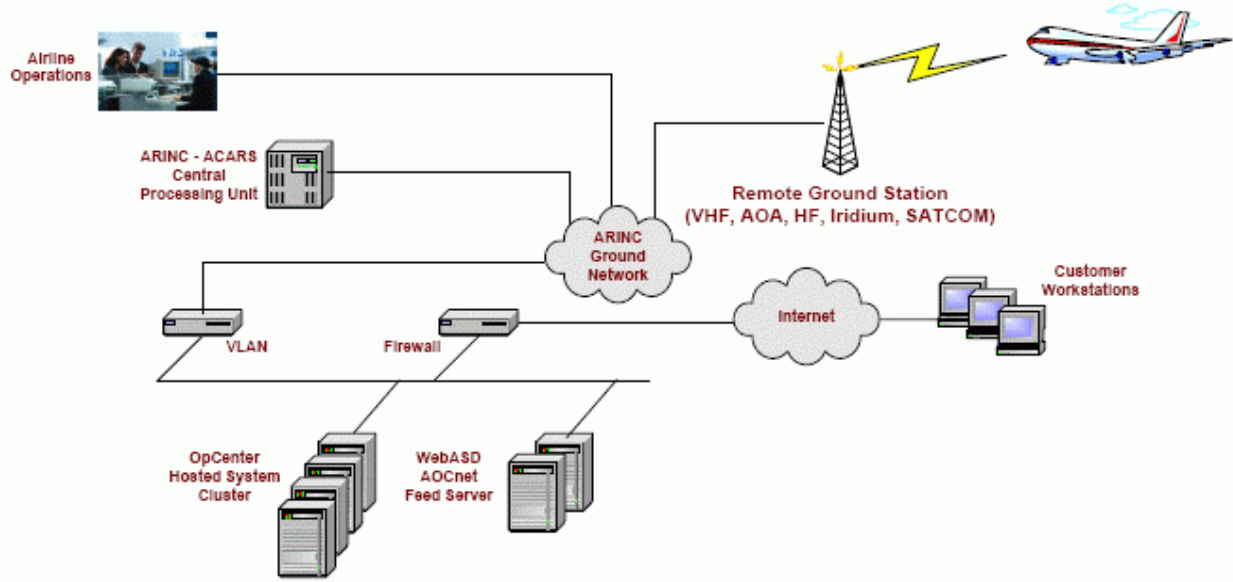
Figure 7 provides an illustration of ARINC's TAPS Air-Ground Communications System architecture. Aircraft downlink TAPS reports to ARINC's ground network via one of several media (i.e., Very High Frequency (VHF), ACARS Over Aviation VHF Link Control (AOA), High Frequency (HF), Iridium, or Satellite Communications (SATCOM)). These reports are then forwarded to the ACARS Central Processor, which then routes them to the appropriate ground application. In the case of TAPS, these reports are forwarded to the OpCenter<sup>SM</sup> Hosted Messaging System, which extracts the TAPS information from the downlink, reformats the message, and forwards it to the WebASD<sup>SM</sup> application. WebASD<sup>SM</sup> processes this information into a form that can be displayed to the dispatcher and analyzed by engineering. Both dispatchers and engineers can access the WebASD<sup>SM</sup> application from the Internet or through dedicated ground circuits.

**Figure 7: ARINC TAPS Air-Ground Communications System Architecture**

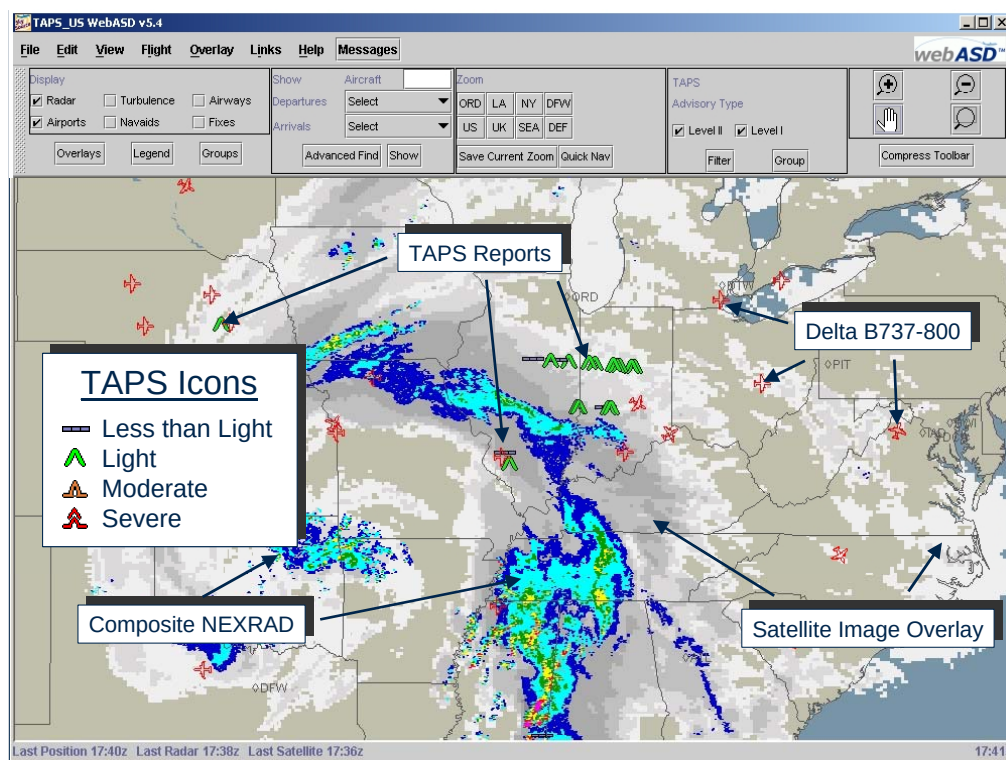
Figure 8: TAPS-WebASD<sup>SM</sup> Display

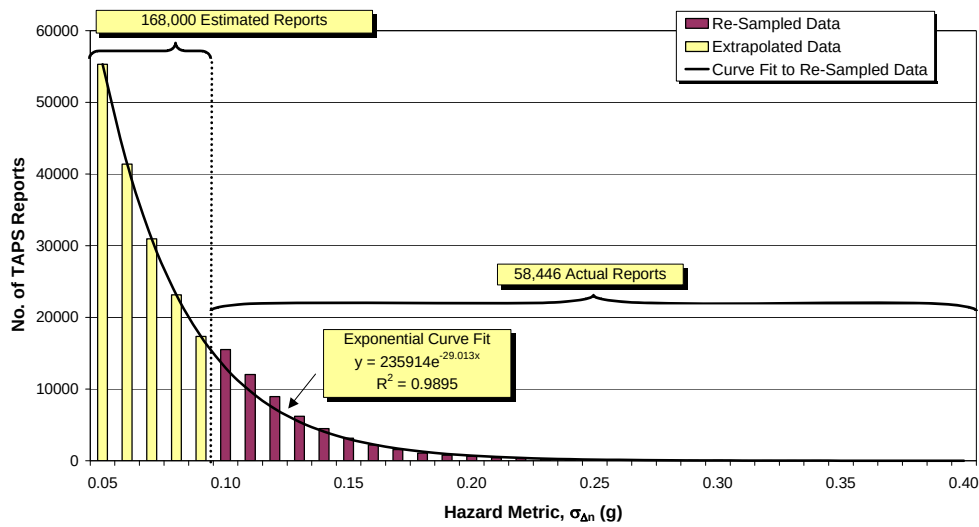
Summing the number of reports for each bin from 0.05g to 0.1g, it is estimated that an additional 168,000 TAPS reports may have been generated, which yields a 387% increase in the total number of reports. Using the timeframe of the ISE for which TAPS reports were collected, this averages out to an additional 53 TAPS reports per aircraft per month. Combining the extrapolated data with the ISE results, if the TAPS reporting threshold had been lowered from 0.1g to 0.05g, a TAPS-equipped aircraft may have generated approximately three TAPS reports per day. This volume of TAPS reporting is negligible when compared to the amount of data currently downlinked daily.

**Figure 18: Curve Fit Applied to Re-Sampled TAPS Report Data**

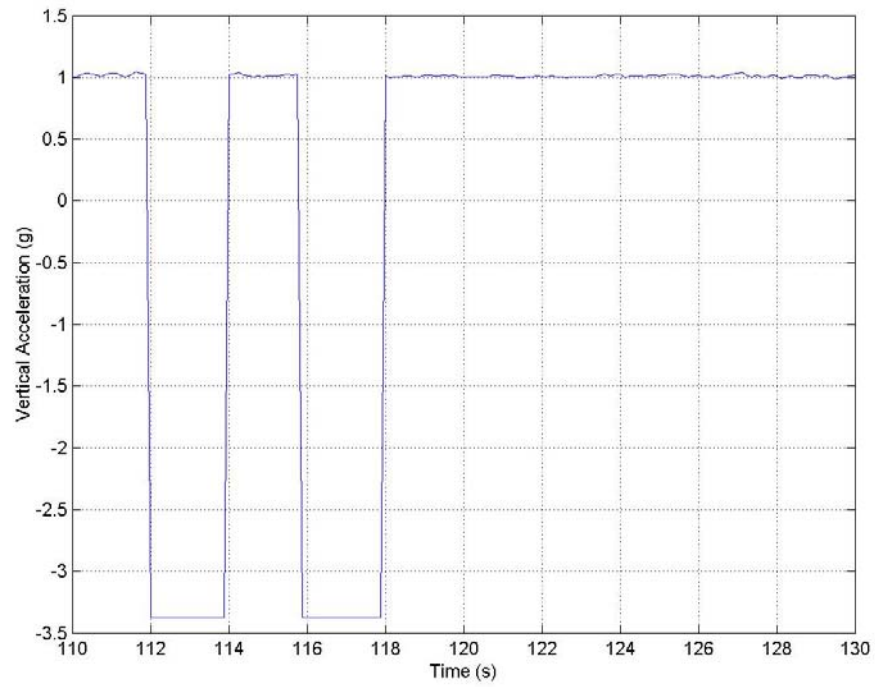
**Figure 25: Databus Dropout in Vertical Acceleration**

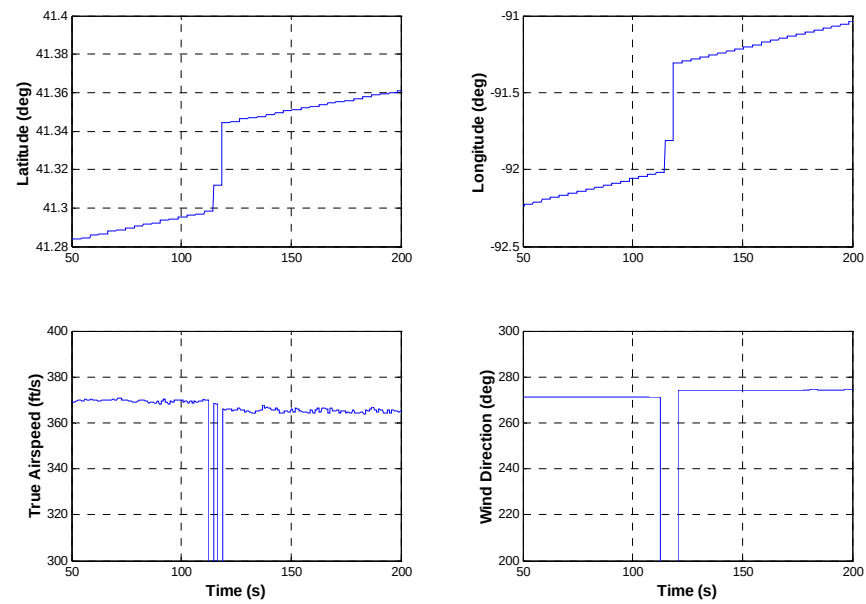
**Figure 26: Databus Dropout Examples**

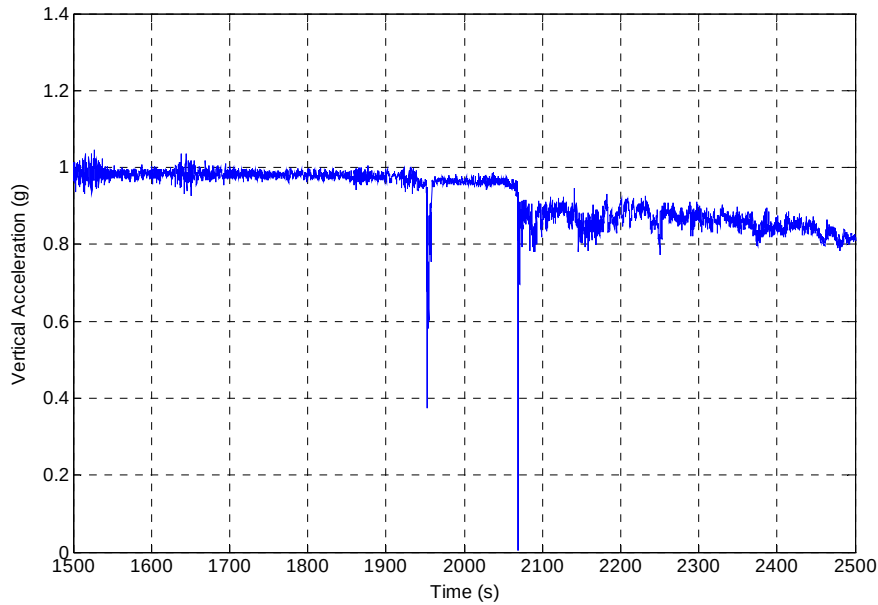
**Figure 27: Example of Erroneous Sensor Data (Vertical Acceleration)**

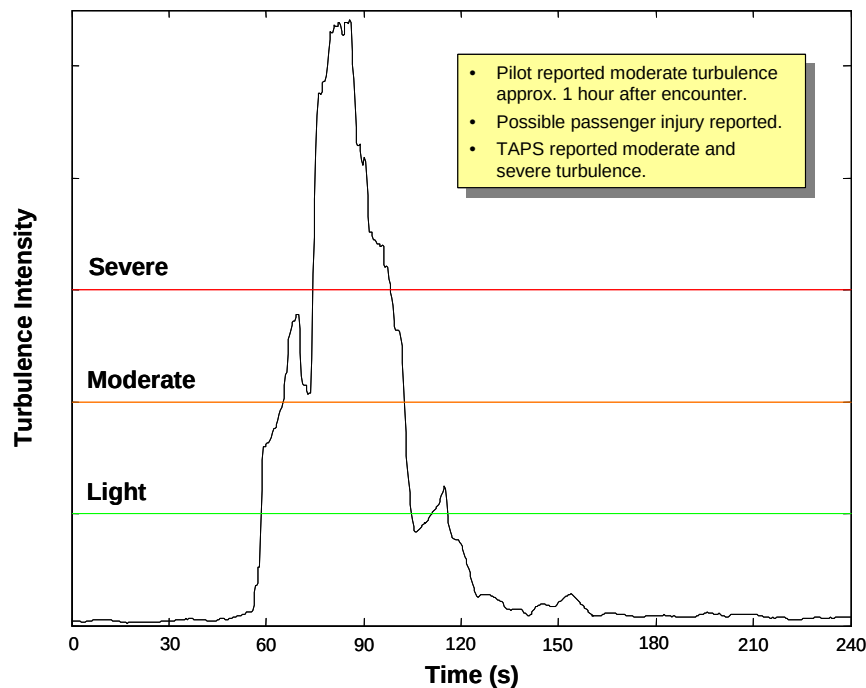
Figure 28 shows data from a flight in which the pilot reported a moderate turbulence encounter. This PIREP was sent approximately one hour after the actual encounter. It was also reported that the flight crew was investigating a possible passenger injury due to the turbulence. TAPS reported moderate and severe turbulence. Since the manual PIREP was made an hour after the encounter, it becomes less useful in improving the situational awareness of other aircraft in the vicinity. These aircraft could have possibly traversed that same region without ever being aware that a flight ahead of them encountered this level of turbulence.

**Figure 28: PIREPs vs. TAPS Underestimation**

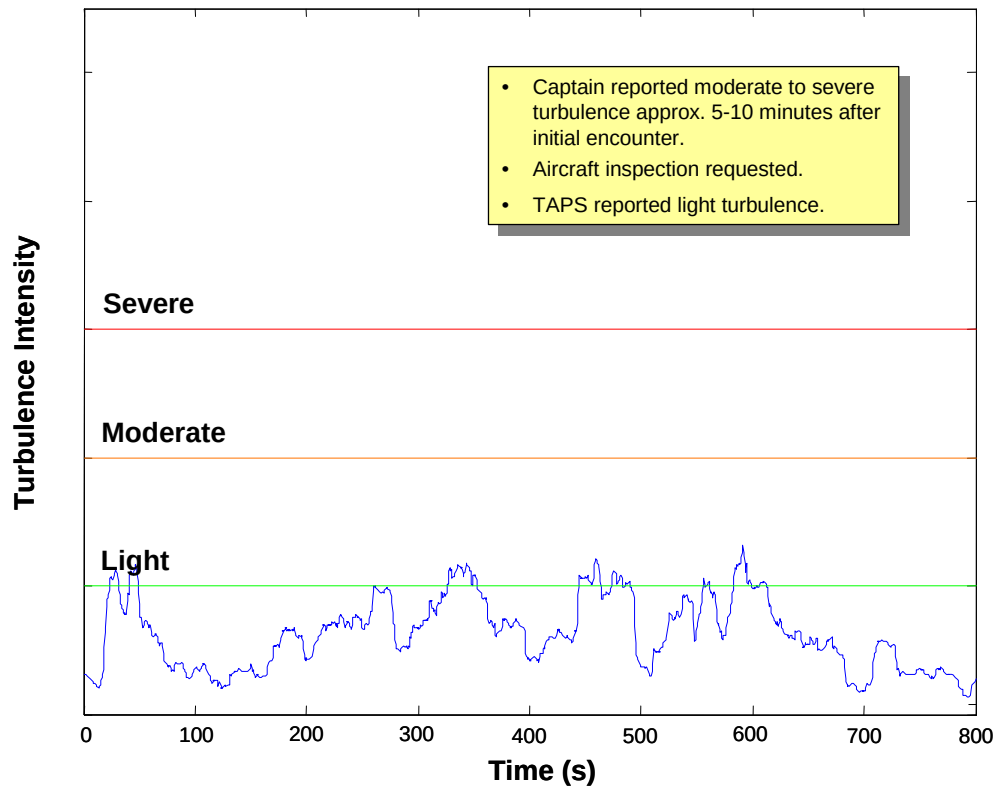
**Figure 29: PIREPs vs. TAPS Overestimation**

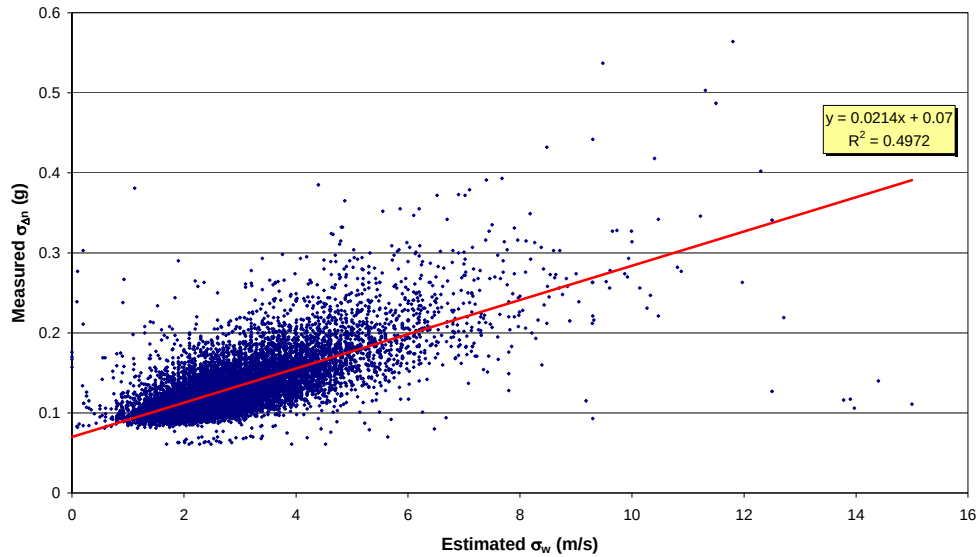
During the B767 evaluation, whenever an aircraft encountered turbulence, a TAPS report was downlinked containing the maximum  $\sigma_{An}$  experienced and maximum  $\sigma_w$  calculated. A total of 12,545 TAPS reports generated from the B767-300ER/400ER aircraft fleets were used for this analysis. All of these reports are shown in Figure 30. A linear regression was applied to the data, and a weak correlation is evident between the measured  $\sigma_{An}$  and estimated  $\sigma_w$ .

**Figure 30: Comparison of Measured  $\sigma_{Dn}$  to Estimated  $\sigma_w$**

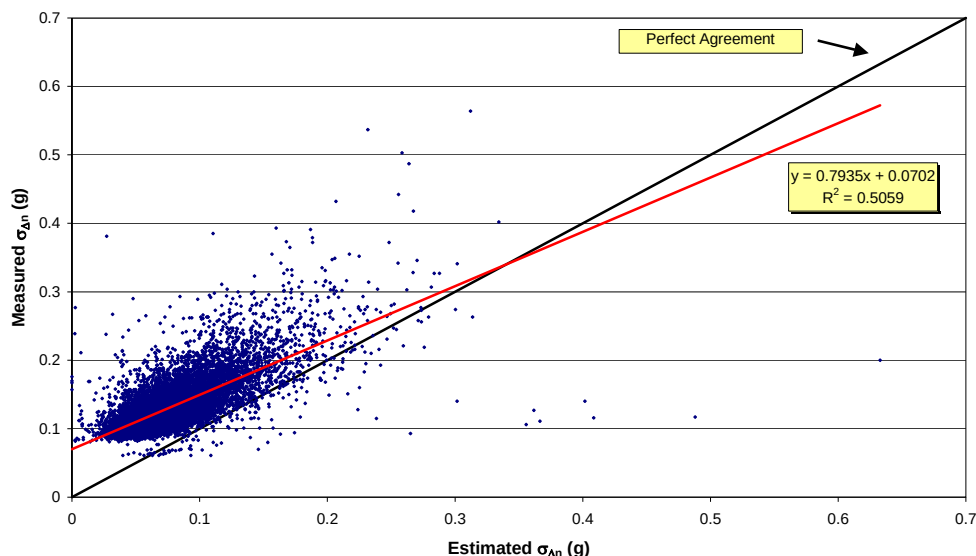
This analysis suggests that an atmospheric parameter such as  $\sigma_w$  would not suffice as a surrogate for  $\sigma_{\Delta n}$ . AeroTech did not receive any flight data from Delta to investigate this further, and it was not possible to estimate the magnitude of the error.

**Figure 31: Comparison of Measured  $\sigma_{\Delta n}$  to Estimated  $\sigma_{\Delta n}$**

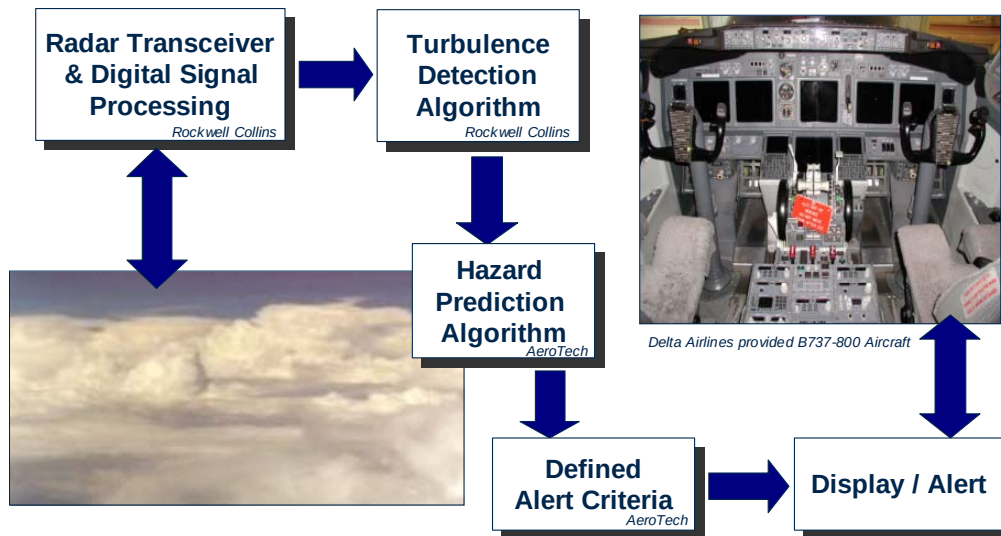
The evaluation of the new radar technology involved several new key features. The program saw the insertion of a new, highly automated WXR-2100 Multiscan™ transceiver technology that provides improved performance with many automated features and a 2<sup>nd</sup> moment detection algorithm with performance characteristics equivalent to the one successfully demonstrated in NASA flight experiments. The ISE is a direct transfer of the NASA hazard prediction algorithm technology and related hazard tables tailored to B737-800 commercial operations. Additionally, real-time estimation of the aircraft's weight was interfaced with the radar system to support g-load prediction. A graphical depiction of the overall E-Turb Radar system architecture is shown in Figure 36.

Figure 36: E-Turb Radar System Architecture

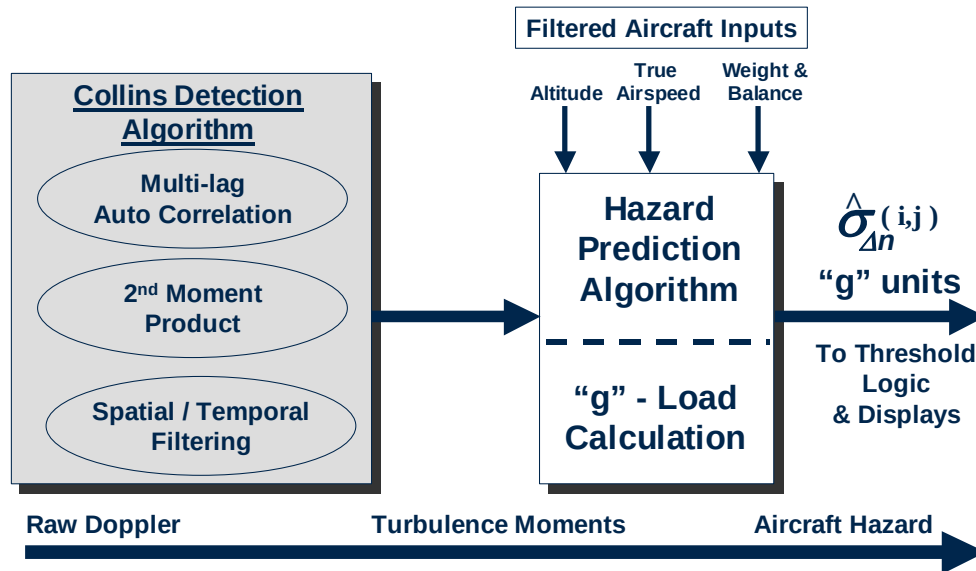
airspeed, and weight are used in the hazard prediction algorithm to scale the 2<sup>nd</sup> moment to a predicted  $\sigma_{\Delta n}$ . The E-Turb Radar features include a presentation of the predicted turbulence impact as a  $\sigma_{\Delta n}$  (the same hazard metric used for TAPS).

**Figure 37: E-Turb Radar Technology System Concept**

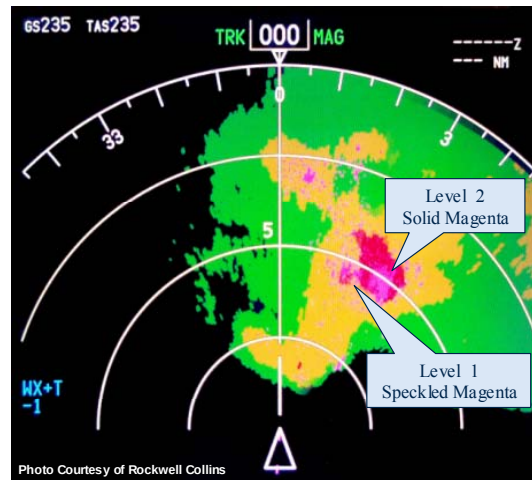
Figure 38 illustrates the two-level threshold presentation of the detected turbulence to an aircraft's crew.

**Figure 38: Cockpit Presentation of Turbulence by the E-Turb Radar**

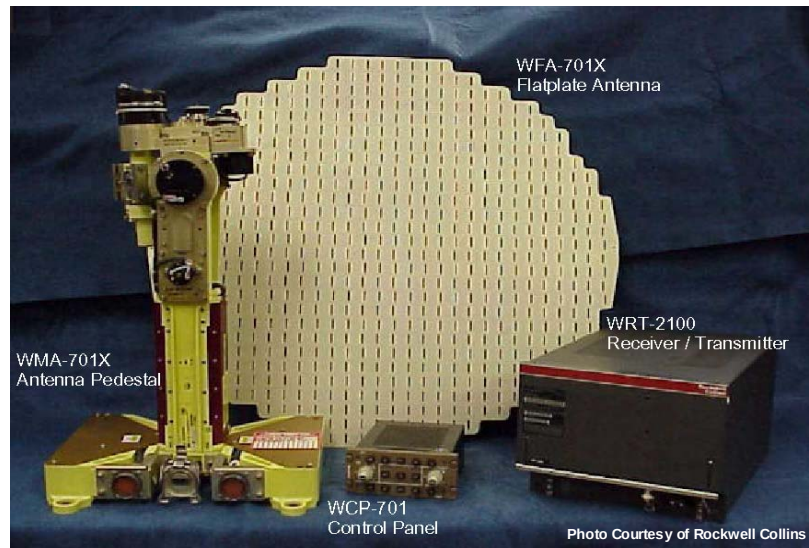
As part of the initial feasibility study conducted in August 2003 with Honeywell and Rockwell Collins, the Rockwell Collins WXR-2100 Multiscan<sup>TM</sup> radar was selected for the E-Turb development and the ISE. The components of the WXR-2100 Multiscan<sup>TM</sup> radar are presented in Figure 39.

**Figure 39: Rockwell Collins WXR-2100 Multiscan™ Radar**

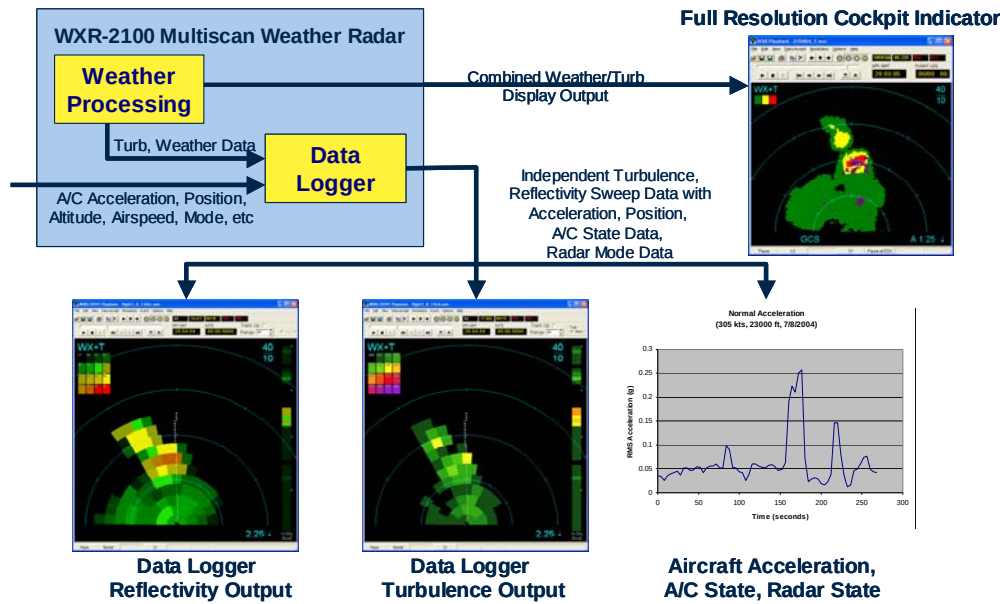
mode data were recorded for accurate data evaluations. The spatial resolution of the radar display information (turbulence and reflectivity) was reduced in comparison to that displayed on the aircraft due to the memory limitations of the data logger hardware.

**Figure 42: Integrated Radar Data Logger Stores Reflectivity and Turbulence Scan Data**

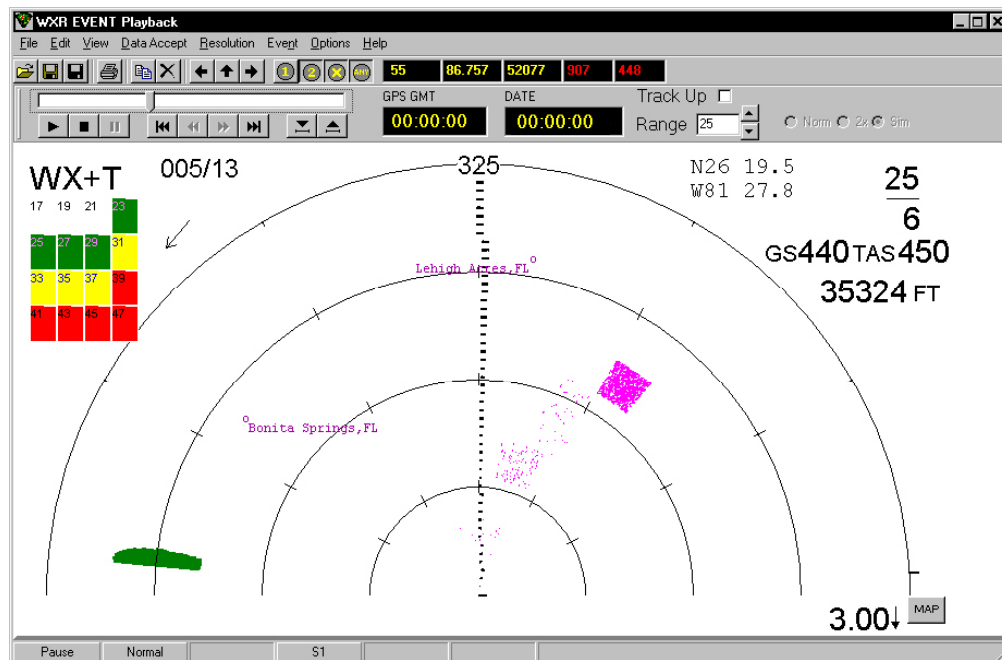
Figure 43 shows the recorded radar display from a DAL 3708 flight. There are convective cells in the vicinity of the aircraft (denoted by the green region in the bottom left). The dotted line is the aircraft's subsequent flight path superimposed on the image. The radar has detected regions of light to moderate turbulence (speckled magenta – Level 1), and a region of greater turbulence intensity (solid magenta – Level 2). These regions were detected in areas of reflectivity less than 20 dBz, which is where normal radars show black or no reflectivity. In fact, in this case the reflectivity in the region of solid magenta was 4 dBz. This event is representative of historical accident cases where the pilot does not see a reflectivity signature on the radar display yet encounters significant turbulence. The E-Turb Radar was capable of detecting these types of hazards. Although the predicted region is not corroborated by the aircraft's penetration of the area, the statistical analysis presented later provides a significant level of confidence in this enunciation.

**Figure 43: Representative DAL 3708 Encounter, Scan 55**

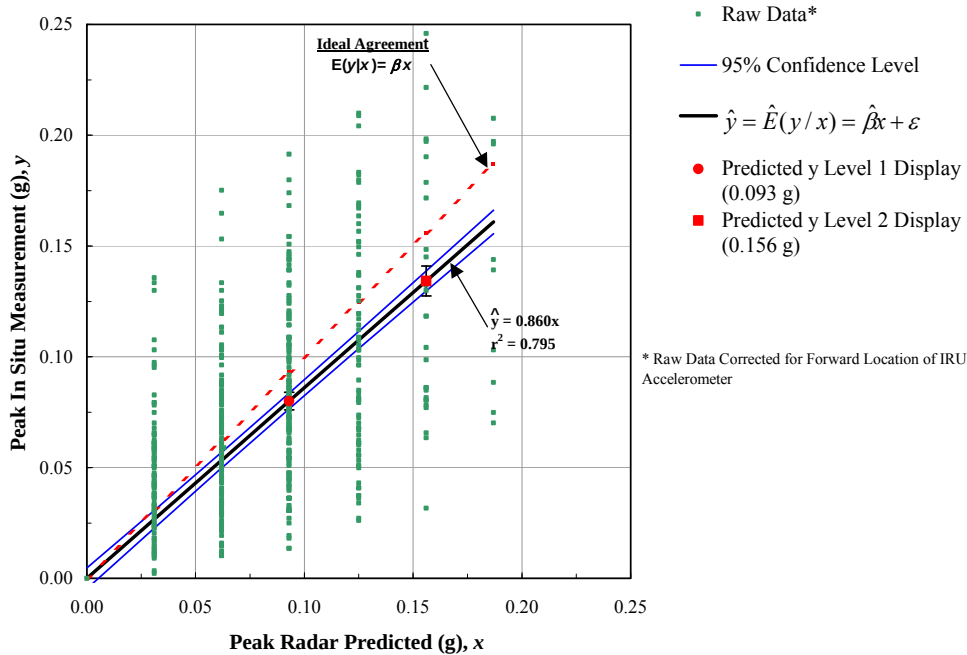
**Figure 46: Correlation of Radar Predicted & In Situ Peak  $\sigma_{An}$**

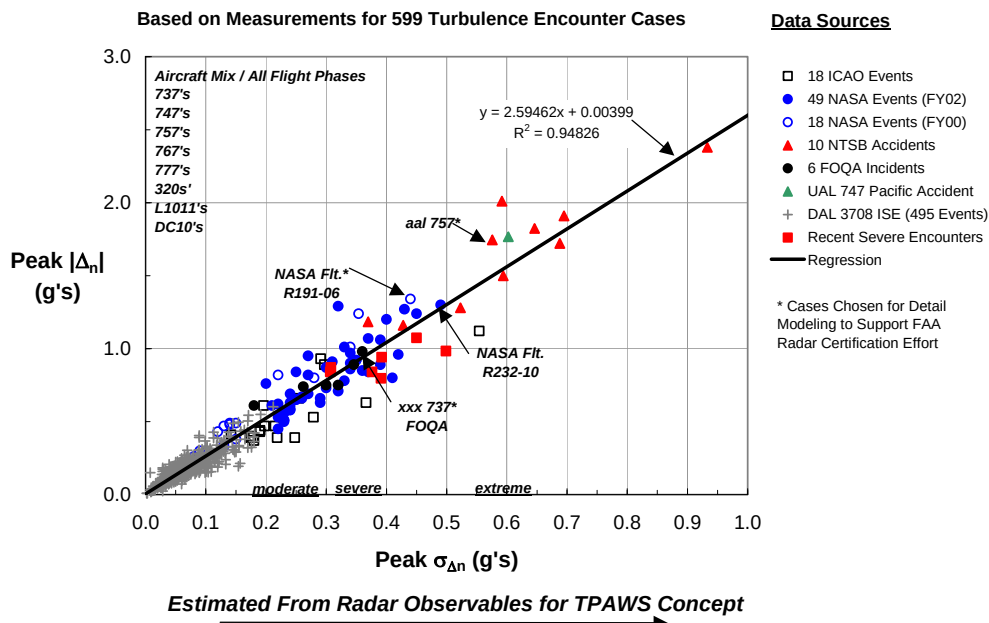
**Figure 49: Correlation of Peak Load With Peak  $\sigma_{\Delta n}$  (5 sec. window)**

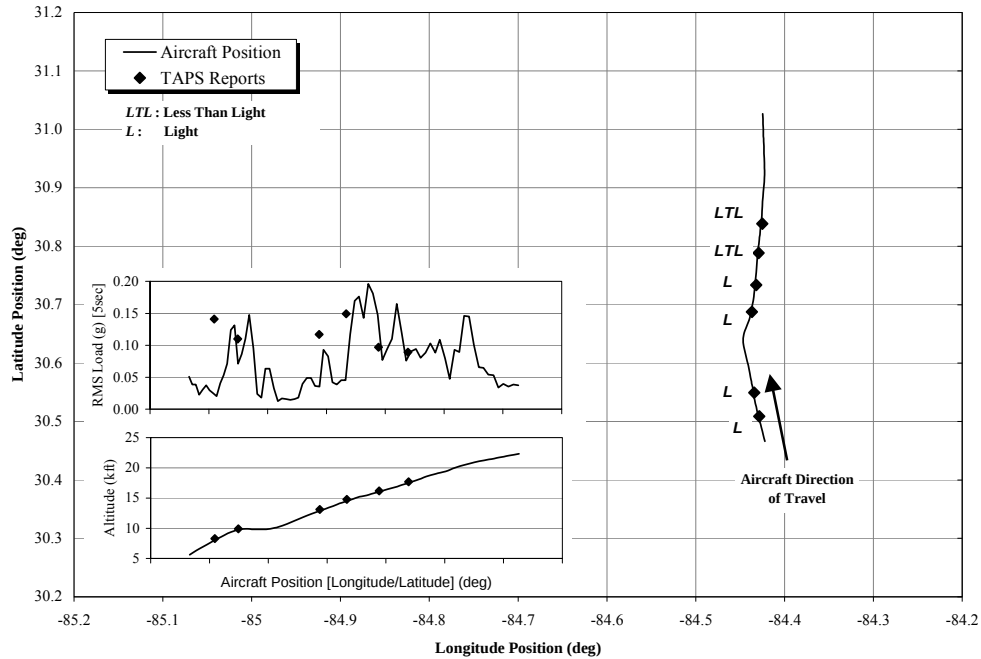
**Figure 53: DAL 3708 Turbulence Encounter Day A-11, Event 42 Detailed View**

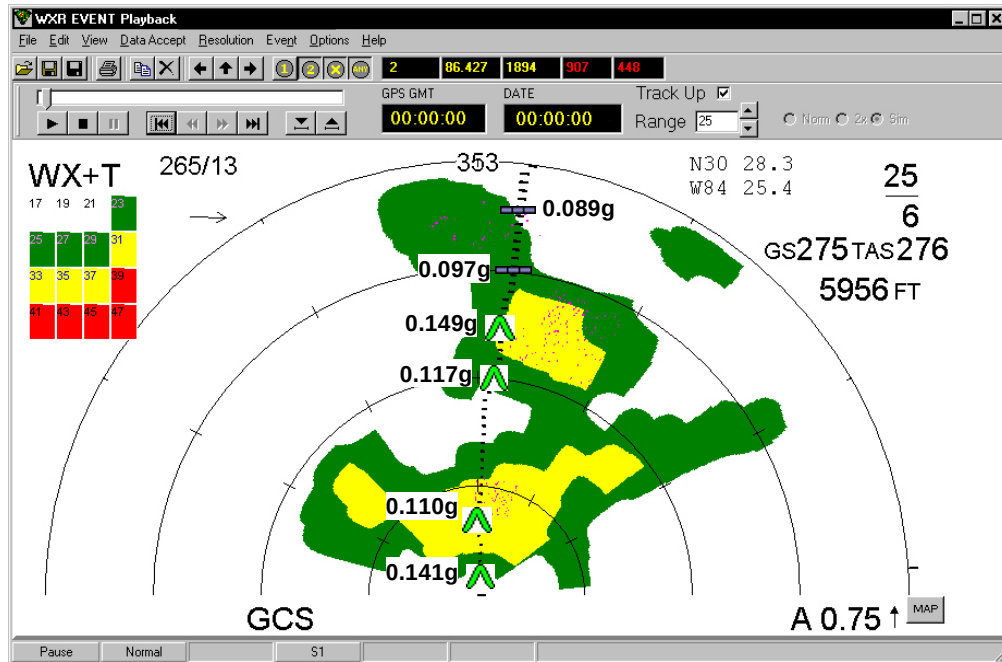
Early during the playback of Event 42, an intense convective cell with red reflectivity remained present through most of the scans to the right of the intended flight path of the aircraft. Small areas surrounding this region were highlighted by a Level 1 prediction. The recorded flight path of DAL 3708 shows the aircraft just passing the left edge of this region.
